PUBLIC SIDEWALK INVENTORY ANALYSIS REPORT

JANUARY 2018

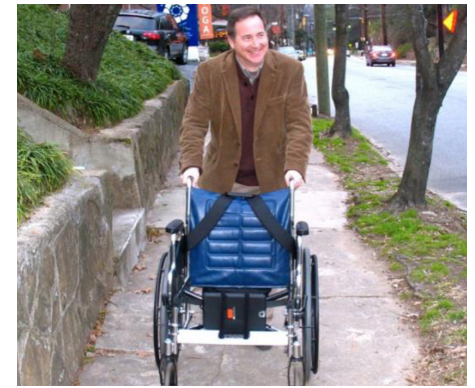
Figure 1.1: The Sidewalk Sentry data collection system utilized a tablet which recorded rolling video along with tilt and vibration information.

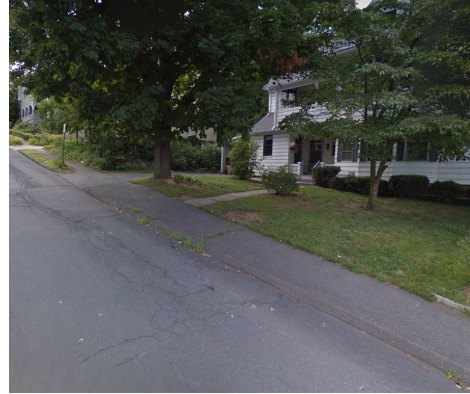
CROSS SLOPE

A segment of sidewalk that exceeds the ADA-accessible 2% maximum cross slope. Image: Google.

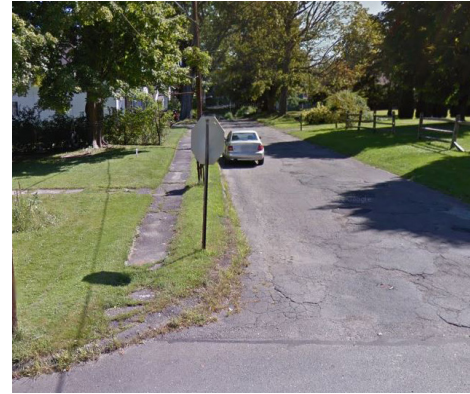
WIDTH

A narrow sidewalk segment on Hinckley Street that does not meet ADA requirements. Image: Google.

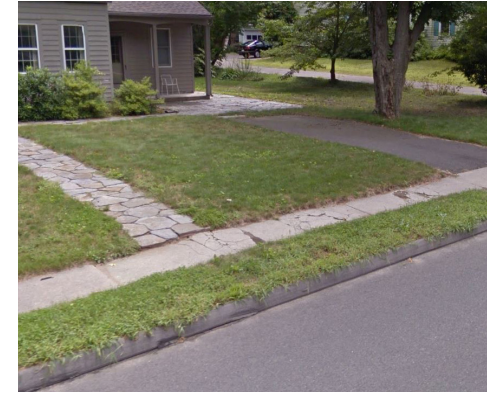
POTHOLES

A segment along Prospect Ave that registered the highest pothole count, creating a challenging environment for those with limited mobility. Image: Google.

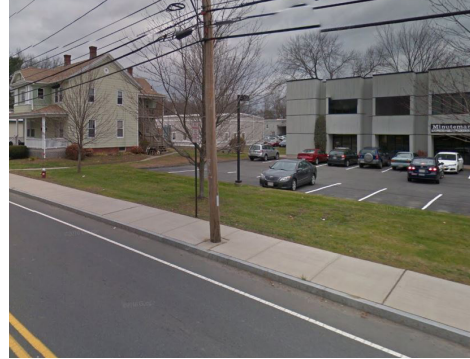
OBSTRUCTIONS

This segment along Conz Street includes utility pole obstructions that narrow the sidewalk width to less than 3' in places. Image: Google.

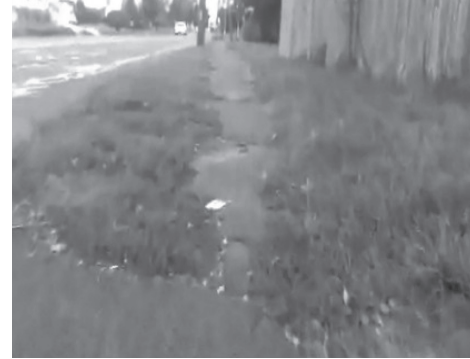
DEBRIS

Sidewalk with significant debris in the form of vegetation encroachment, making the sidewalk inaccessible for wheelchairs. Image: screen shot from the rolling wheelchair tablet video.

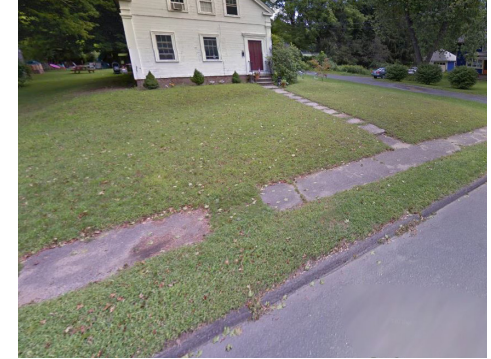
UNEVEN SURFACES

A sidewalk with significant uneven surfaces on Federal Street, rendering the segment non-compliant with ADA standards. Image: Google.

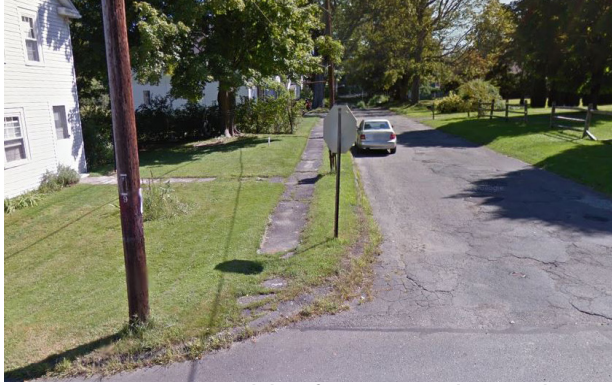
Figure 2.5: A missing (and therefore non-compliant) pedestrian curb ramp on Hinckley Street. Image: Google.

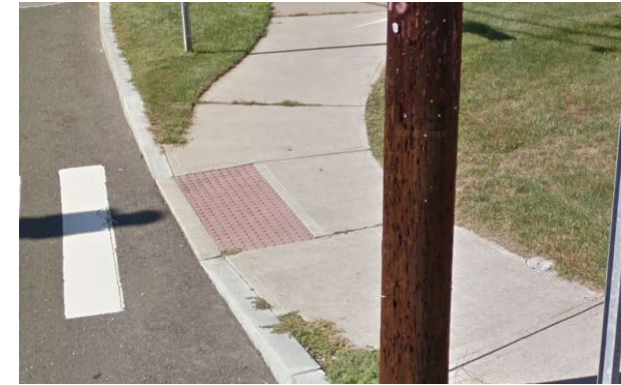
Figure 2.8: A compliant pedestrian curb ramp on Prospect Street at N Elm Street. Image: Google.

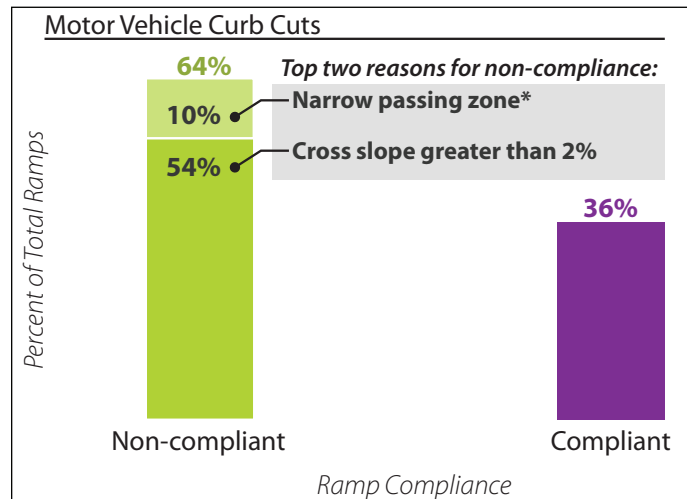
Figure 2.12: Motor Vehicle Curb Cuts Compliance

*Width of sidewalk between top of the curb cut and back of sidewalk is < 3'-0"

A variety of measurements and other specific details were recorded at each pedestrian curb ramp location (see Appendix 1 for types of measurements). Figure 2.12 highlights the two primary factors that triggered curb cut non-compliance: a narrow passing zone and cross slope > 2%.

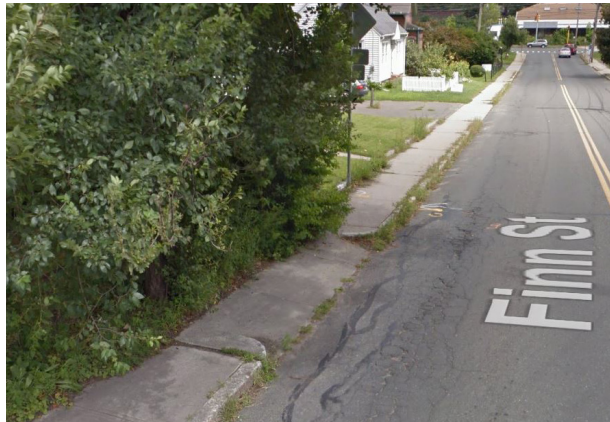
Figure 2.13: An example of a non-compliant (and defunct) curb cut on Finn Street just east of State Street. Image: Google.

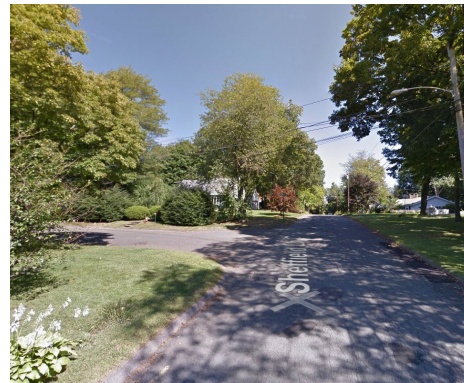
TIER A

Both Sheffield Lane and Hillcrest Drive (intersecting from the left) are missing sidewalks on both sides of the street, and are within 1/2 mile of Florence Center, therefore both of these streets fall under the Tier A category. Image: Google.

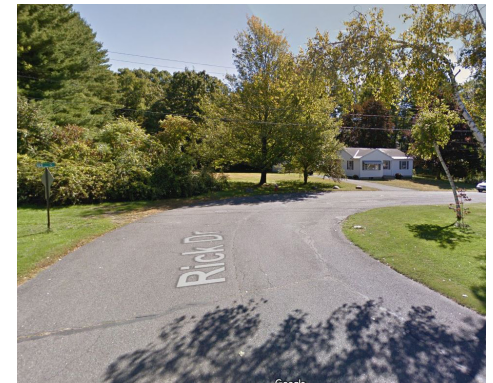
TIER B

Both Rick Drive and Maryjane Lane (intersecting from the right) are missing sidewalks on both sides of the street, and fall within 1/2 and 1 mile of Florence center, therefore both of these streets fall under the Tier B category. Image: Google.

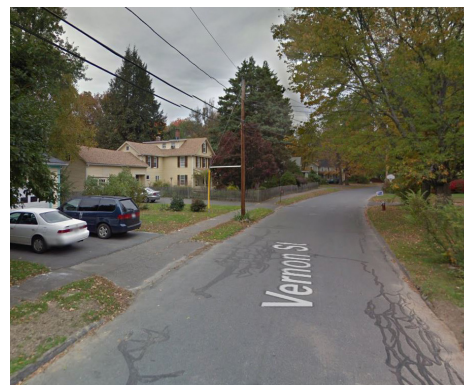
TIER C

Vernon Street is missing a sidewalk along one side of the street, and falls within 1/2 mile of Northampton High School, therefore this street falls under the Tier C category. Image: Google.

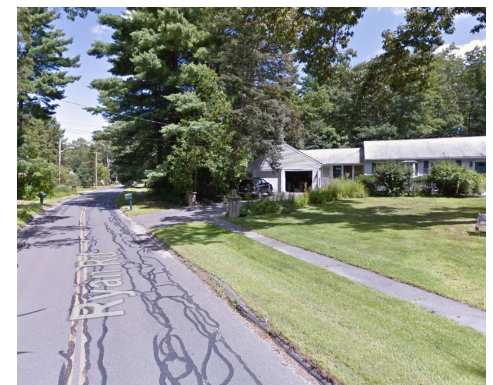
TIER D

Ryan Road near Burts Pit Road is missing a sidewalk on one side of the street, and falls between 1/2 and 1 mile of Ryan Road Elementary School, therefore this street falls under the Tier D category. Image: Google.
