MAIN STREET TREES

Northampton, MA
Map produced by Toole Design May 25, 2021

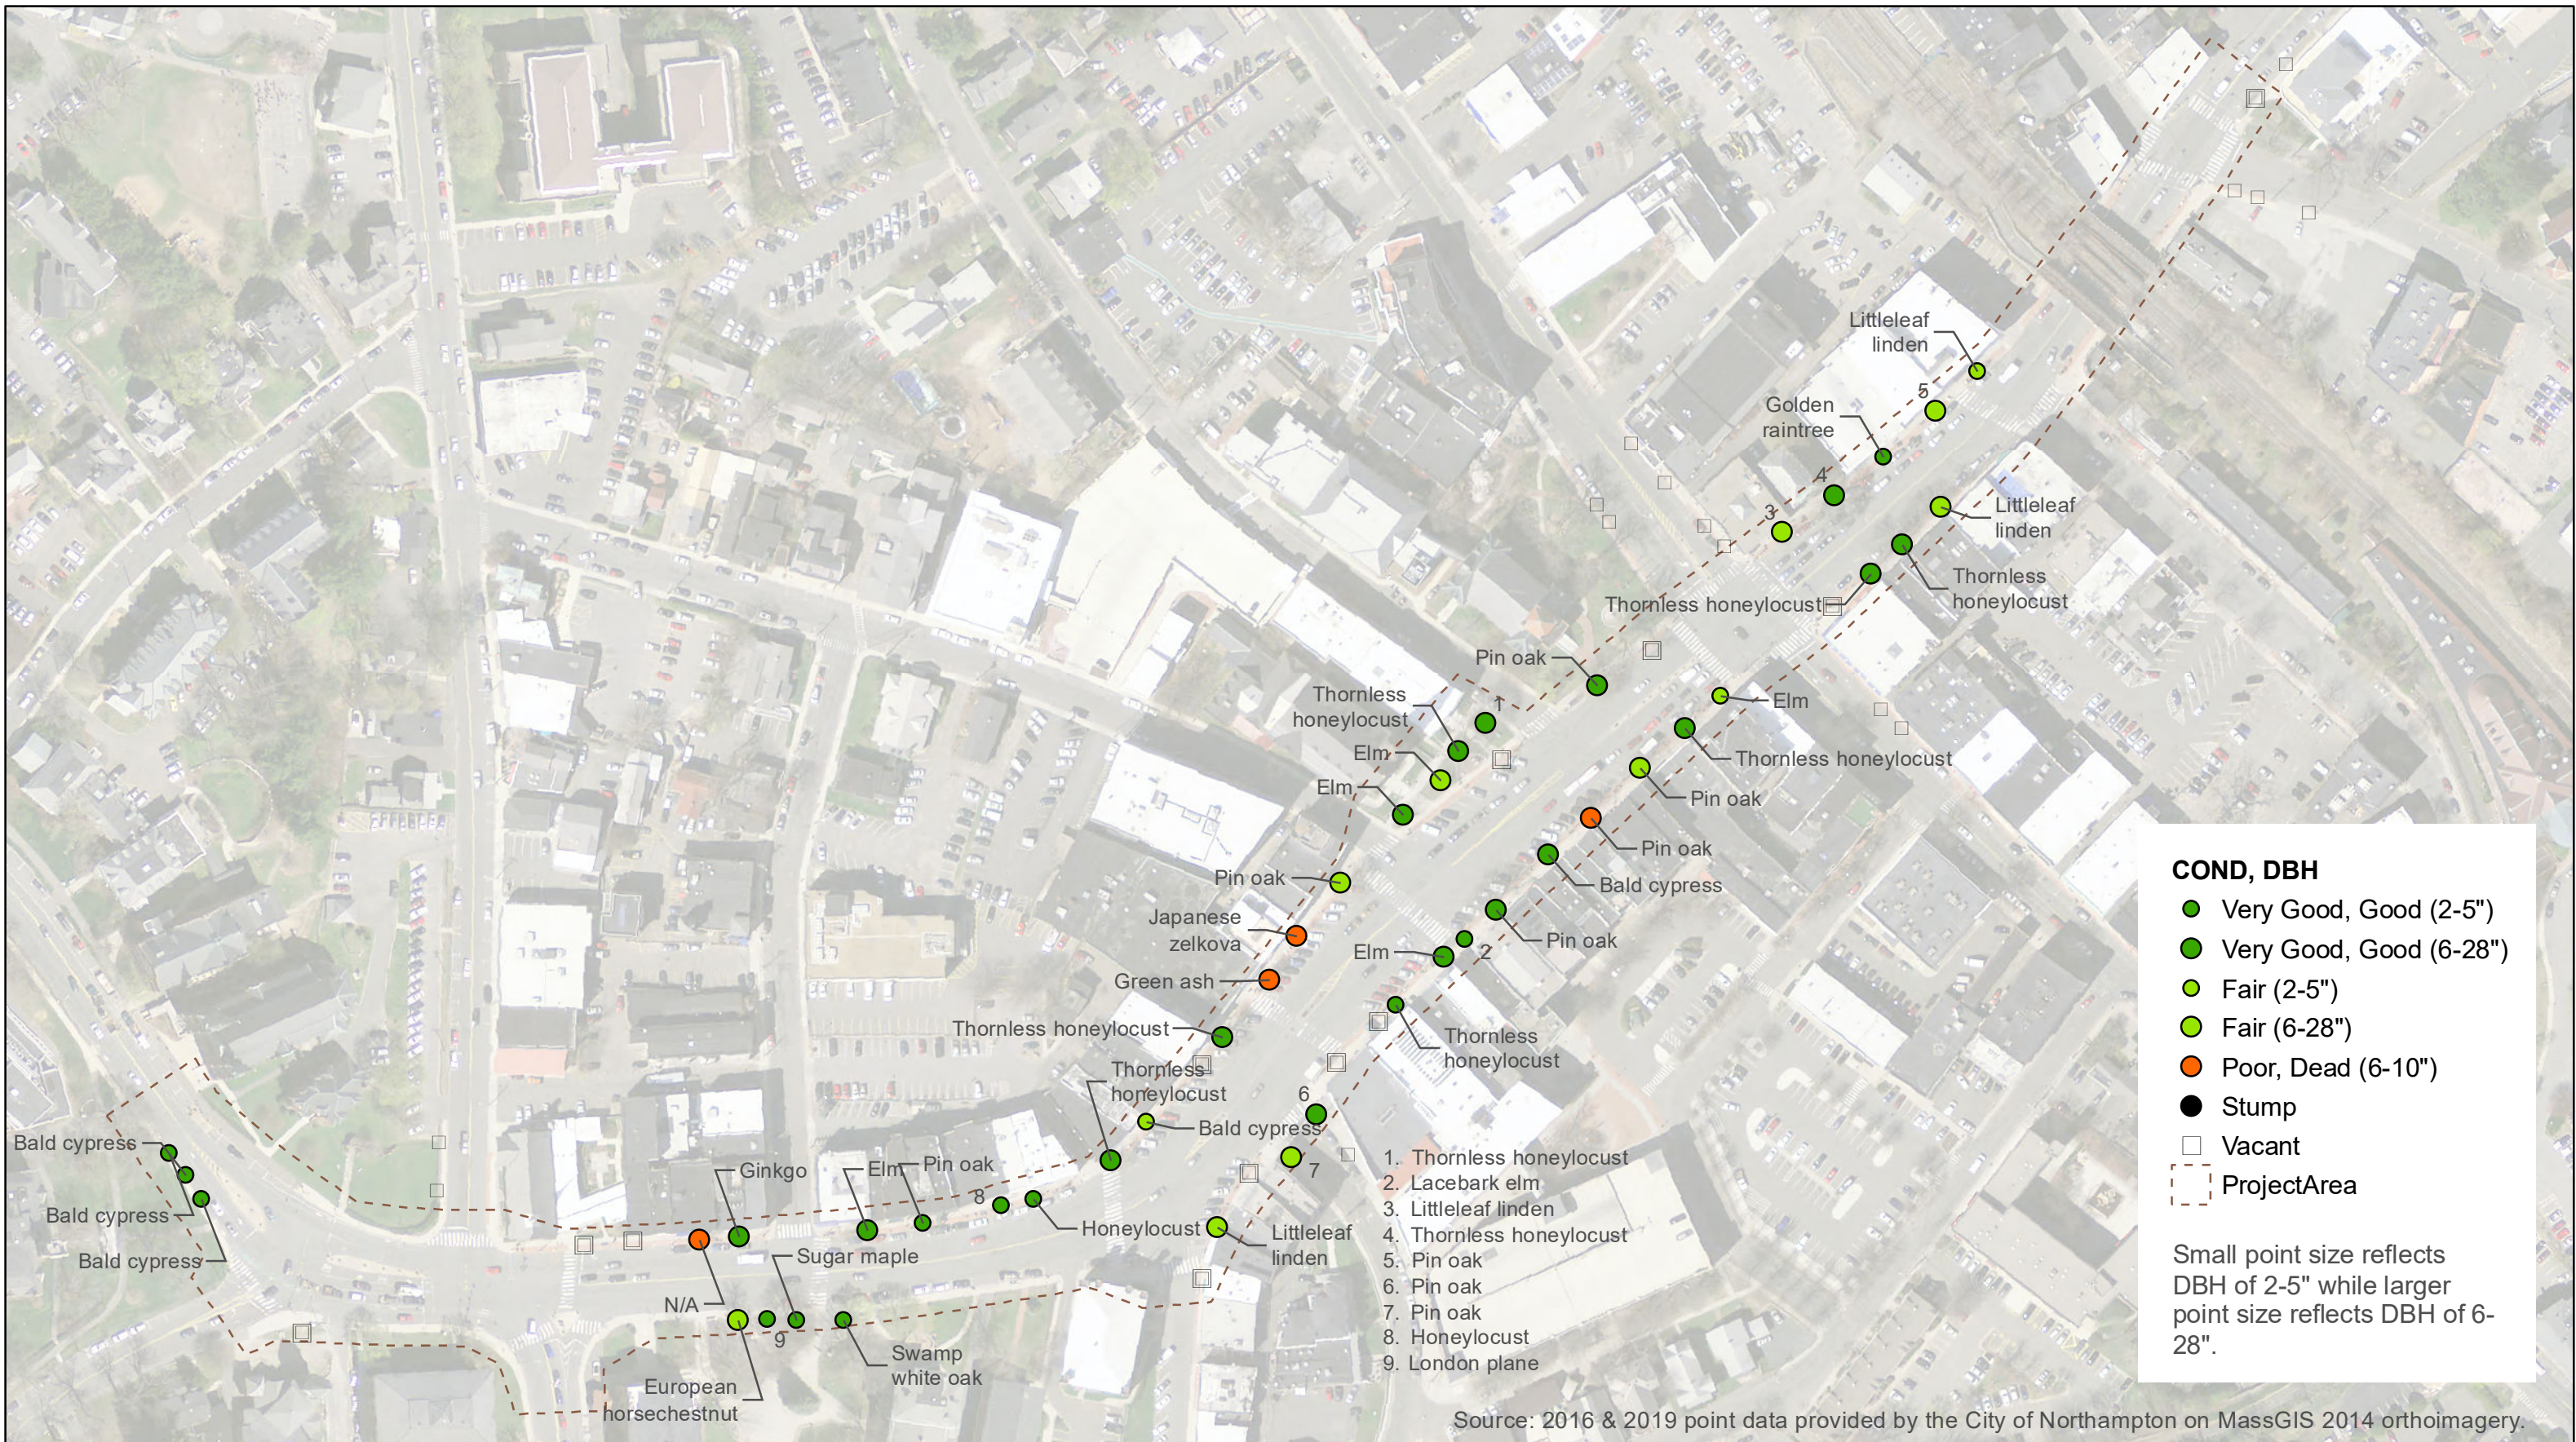
Of the 57 tree pit locations within the project area, 44 were identified as having trees in them: 28 in very good to good condition and 12 in fair condition. Fifteen (15) species are represented, with 20% (9) thornless honeylocust and 20% (9) pin oak as the most common species.
